Final Site Management Plan Fiscal Year 2008

Naval Station Norfolk Norfolk, Virginia

Department of the Navy Naval Facilities Engineering Command Mid-Atlantic Division

Contract No. N62470-02-D-3052 CTO-152

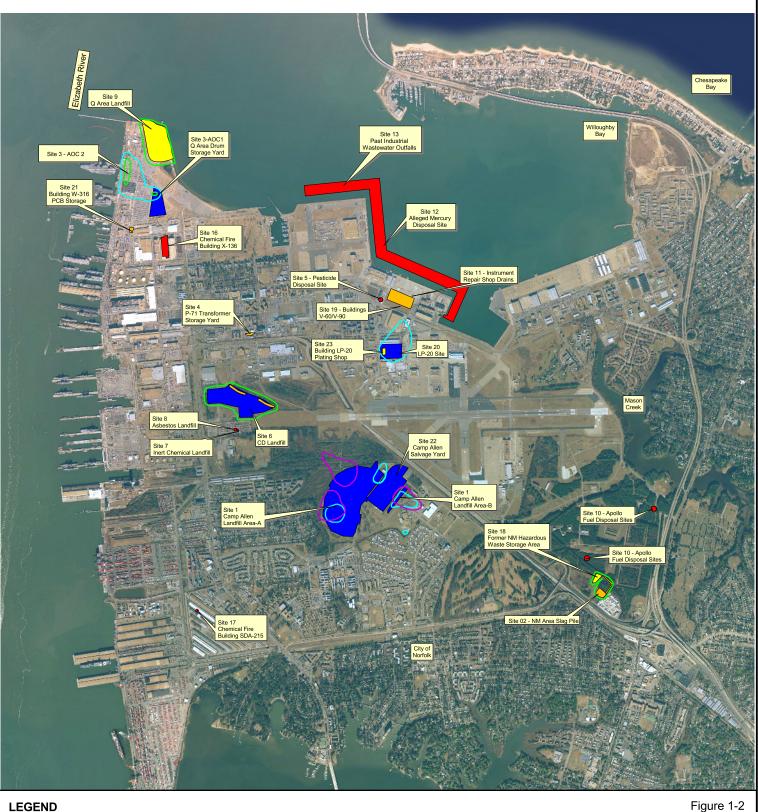
Figure 1-2
Base Map with IRP Site Locations
and Current Clean-up Status
October 2007
Naval Station Norfolk
Norfolk, Virginia
3000 Feet

Remedial/Removal Action Complete Remedial/Removal Action in Progress Remedial/Site Investigation in Progress 0 1500 3

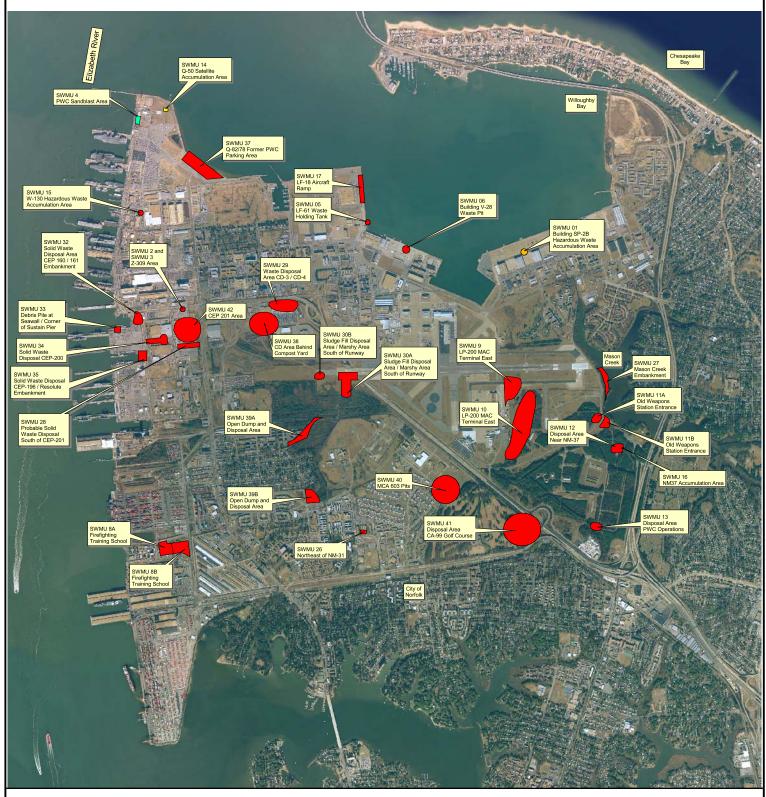
Figure 1-4 Base Map Additional SWMU Locations and Current Clean-up Status September 2007 Naval Station Norfolk Norfolk, Virginia

NFA Sites Per FFA Close-out Reports
Remedial/Removal Action Complete
Remedial/Site Investigation in Progress
Transferred from CERCLA Program
